National Register of Historic Places
Registration Form

historic name Dorsey Hall

other names HO-28

street & number 5100 Dorsey Hall Drive

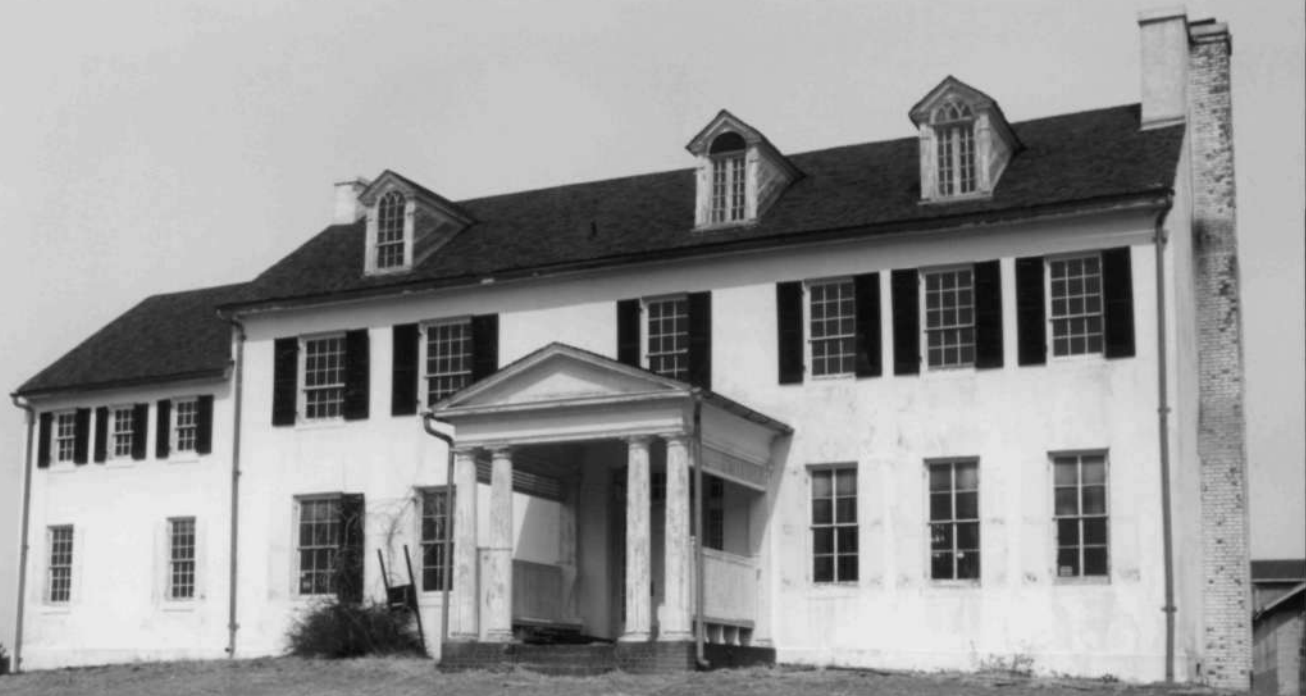
1/17

South elev.

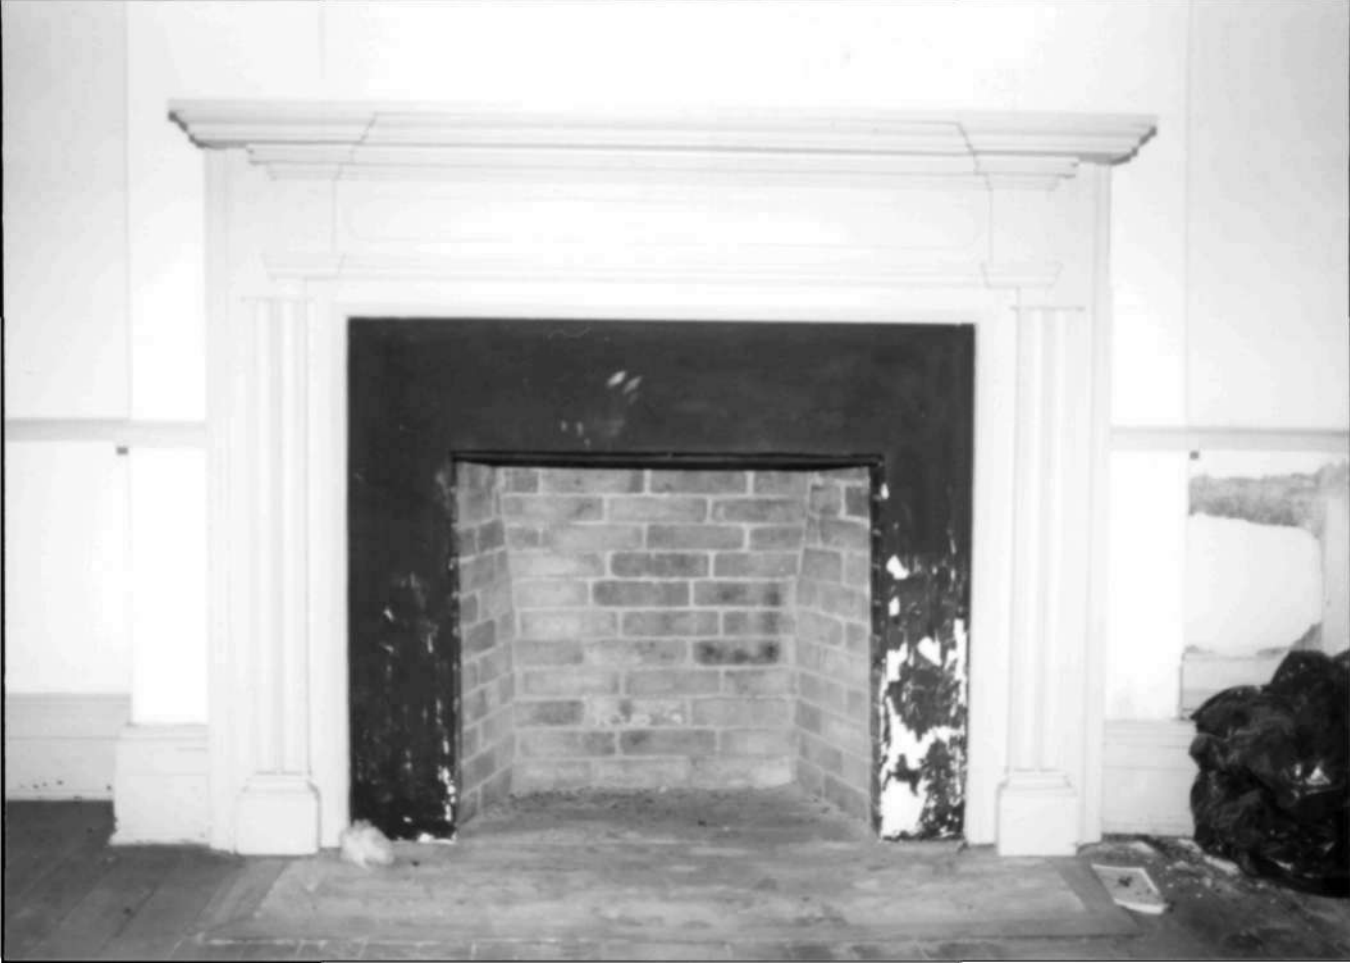
8/17

South-center room mantel

The south center room flooring is random width pine between 3 3/4 and 4 1/2 inches wide, and runs east-west. There are rows of carpet tack holes running east-west, spaced 36 inches apart. The baseboard has a broken field, with a cavetto and bead at the top. The architrave is symmetrical, with three lancet mouldings in the center and a bead on the inner edge. There are bullseye corner blocks that are only the width of the lancet mouldings and not of the whole architrave. The windows have splayed jambs with recessed window wells beneath the sills that have one panel, and one panel on each jamb. The panels are mortised and tenoned and pegged. The panels have sunk fields and steep ovolo and bead panel moulds. Above the sill, the soffit has two panels and each jamb has four panels that align with the six-over-six sash. The sash are mortised and tenoned and pegged, have parting beads, and are hung on metal tapes. There is a chairrail that appears to be upside down, as it is flat on the bottom, has a cavetto on the top, and the dentils are only cut into the top edge. The cornice appears to be wood, and has an ogee above a cavetto. Centered on the west elevation is a fireplace with a brick hearth laid in Portland cement and a new brick fire box that has splayed jambs and one wythe of brick added to the face and parged. There is a wood mantel with symmetrical pilaster strips that have a single lancet moulding in the center. Awkwardly set on top of these are narrow impost blocks that are set off-center. The frieze has a raised oval plaque. The bed mould has a beak mould with a bead above and below it. The mantel shelf has a segmentally curved front that has a Greek ovolo on the

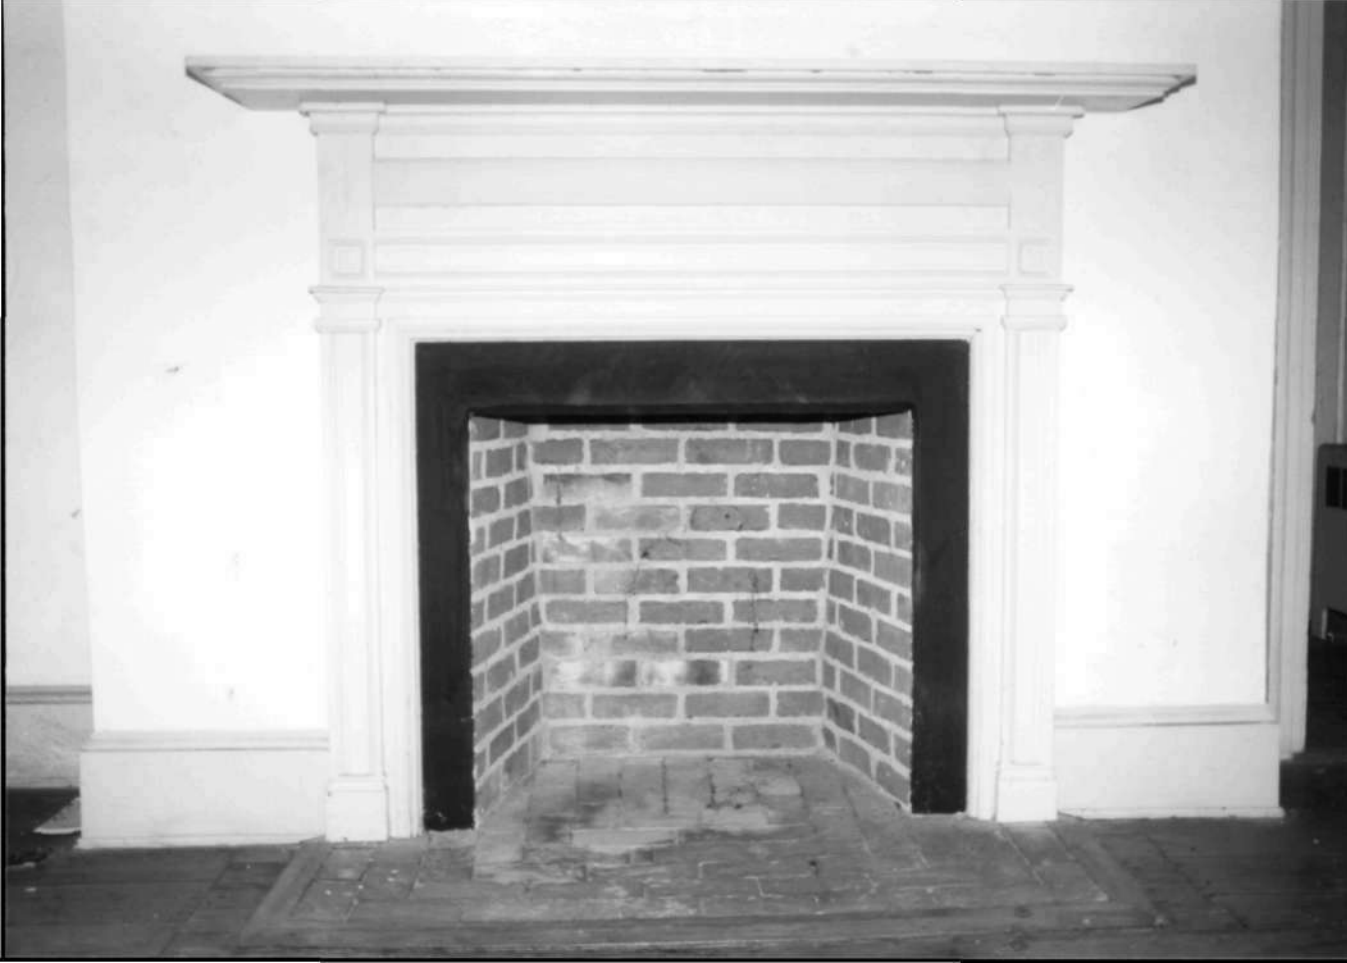
10/17

West Room mantel

edge. There is a new rectangular wood shelf set on top of this, and the mantel has been boxed out on the sides making it project from the wall about 4 inches. The west doorway, which is south of the fireplace, has six panels with sunk fields and ogee panel moulds. The rails and stiles are mortised and tenoned and pegged, and the door is hung on stamped plate hinges with five knuckles that have loose joints. The cast iron rim lock is labeled "PATD MARCH 1, 1870 CORBIN." The end of the door is patched, and there is a round plug below where an earlier lock was, suggesting that there were two previous locks here. The door jambs each have nine panels arranged as three rows of three, and there is a clear break between the east row and the two western rows. The soffit has two panels to the west and four panels to the east. All of the panels are sunk and flat, with ogee panel moulds. The east panel moulds are slightly larger than the west ones. All of the rails and stiles are mortised and tenoned and pegged. There is new flooring in this doorway. North of the fireplace is a painted square of plaster with raw plaster around that must have had wood rails and stiles applied to it to create the appearance of paneling. The existing chair rail seems to cover part of this, suggesting that the rails and stiles were removed before the chair rail was added. The top trim of the baseboard is fastened with wire nails and was clearly added after the bottom rail was removed. The north door has six panels with sunk fields and ovolo and bead panel moulds. The door is mortised and tenoned and pegged and is hung on a pivoting hinge. The edges of the door are rounded off. A door was originally hung on butt hinges here, as the hinge mortises survive on the jamb. The north wall has plaster on sawn lath that is fastened with cut nails that are larger than the cut nails found in the center passage. The studs are sash sawn, are 3 1/2 inches deep, and range from 1 3/4 to 3 inches wide. The ceiling is 10 feet, 4 1/2 inches high.
